Technical Report ARAED-TR-96002

**METALLURGICAL ANALYSIS OF AN ALUMINUM SABOT FIRED
IN THE CANNON CALIBER ELECTROMAGNETIC GUN (CCEMG)**

June 1996

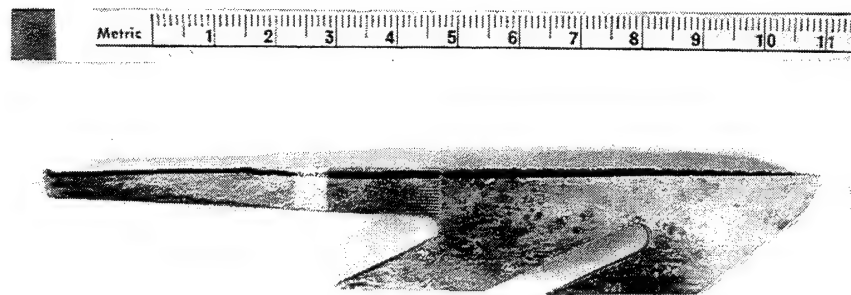
The rear contact surfaces of the sabot melted more and lost more material than the front contacts. This suggests that the rear contacts carried more current and/or had more intimate mechanical contact with the rails. The tips of all of the contact surfaces had melted off and were somewhat deformed.

Figure 1
Sectioned sabot

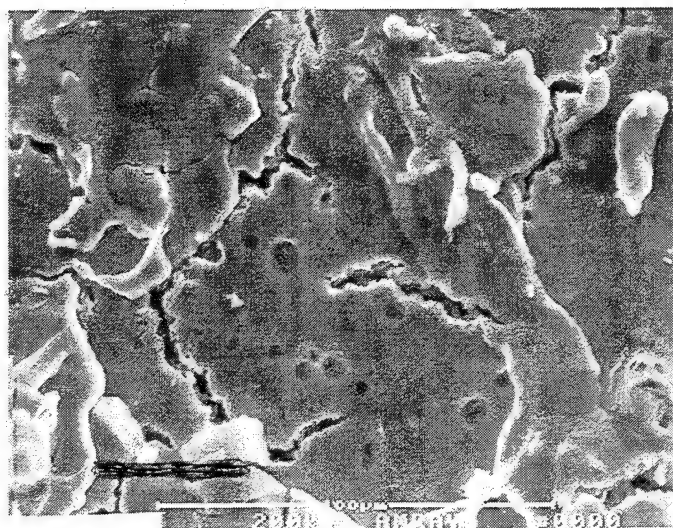
Figure 2 shows an SEM photograph of the rear contact surface near the tip. Bubbles and cracks in the structure are a result of high temperature oxidation (HTO). This occurs when aluminum is heated to its solution temperature or beyond in an atmosphere that contains water. Atomic hydrogen from the water reacts with the aluminum surface and diffuses through the aluminum lattice. The hydrogen then recombines to form molecular hydrogen, which is what causes the bubbles to form.

Figure 2
SEM of rear contact surface (540X)

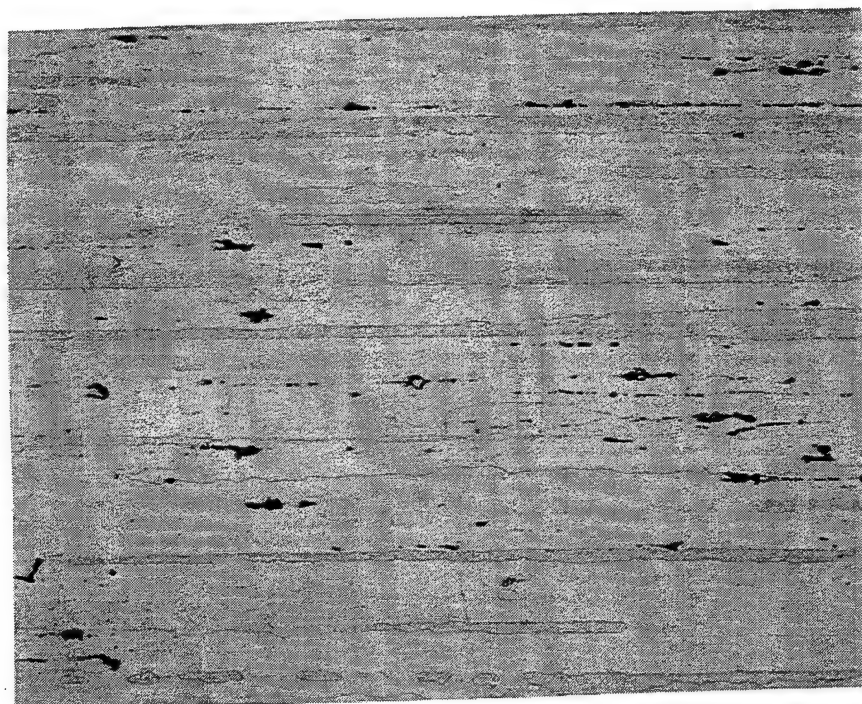
For purposes of comparison, a typical microstructure of forged Al-7475 is shown in figure 3. Here, elongated aluminum grains with insoluble particles and second phase particles of magnesium and silicon are seen.

Figure 3
Microstructure of aluminum 7475 (200X)

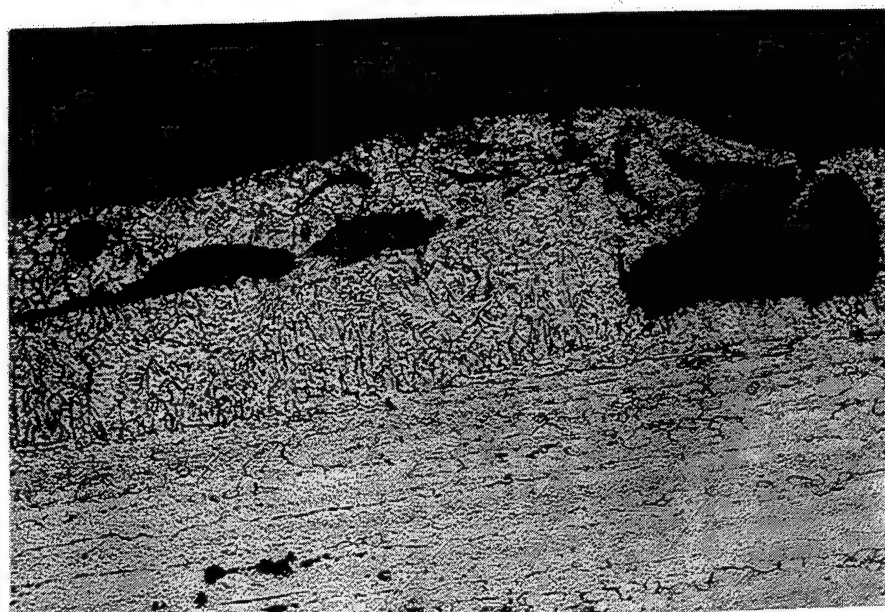
Examination of the sabot microstructure focused on the rear contact surface since it had the highest degree of melting. Figure 4 shows an area of high temperature oxidation in the rear contact surface. Here the aluminum has bubbled, deformed, and resolidified--forming a different microstructure than is typical for Al-7475. In fact, the microstructure in figure 4 is similar to an electron beam welded Al-7475. A network of interdendritic aluminum, magnesium, and silicon compounds has replaced the elongated grains of aluminum.

Figure 4
Microstructure of rear contact surface (500X)

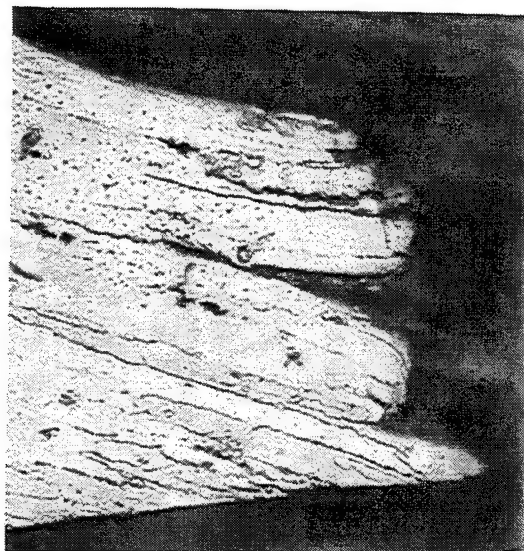
Figure 5 shows the very tip of the rear contact. The temperature was so concentrated that the elongated grains of aluminum have separated along the grain boundaries. This effect is called over-aging.

Figure 5
Microstructure of tip of rear contact surface (75X)

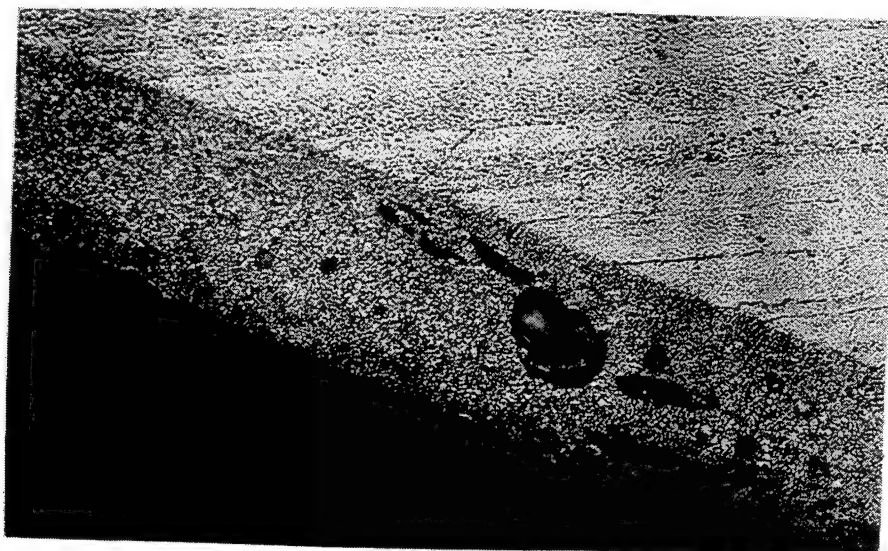
Figure 6 is the microstructure of the area on the bottom side of the rear contact surface. Even though this side did not come in contact with the rails, it also melted, formed bubbles, and developed a microstructure similar to that in figure 4. The bubbles are caused by high temperature oxidation.

Figure 6
Microstructure of bottom-side of rear contact surface (500X)

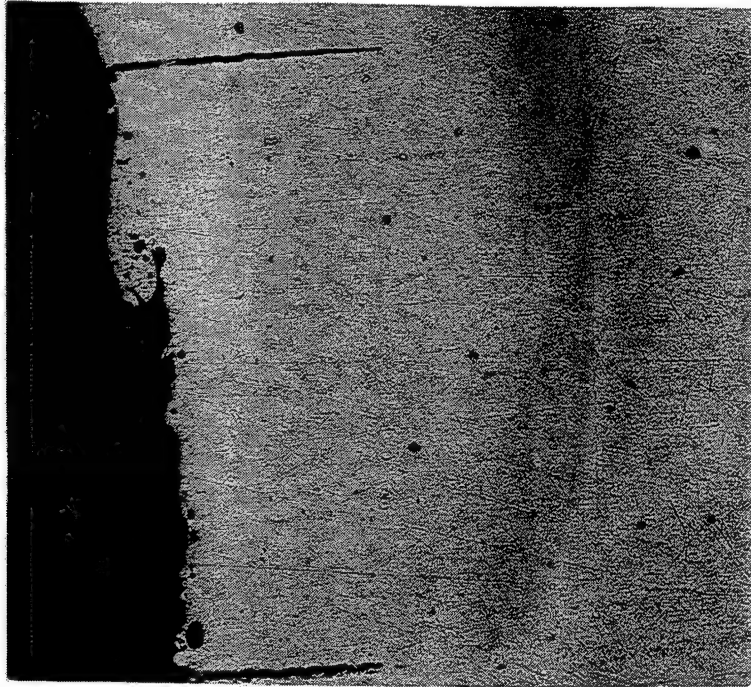
Figure 7 shows a crack that has formed at the root of the back fin. This crack is 350 μ long. To understand the mechanisms of the crack initiation and growth, the area was viewed at a higher magnification (fig. 8). As seen in figures 4 and 6, a section of this microstructure looks similar to an electron beam weld. Next to this microstructure,

Figure 7
Crack formation at root(100X)

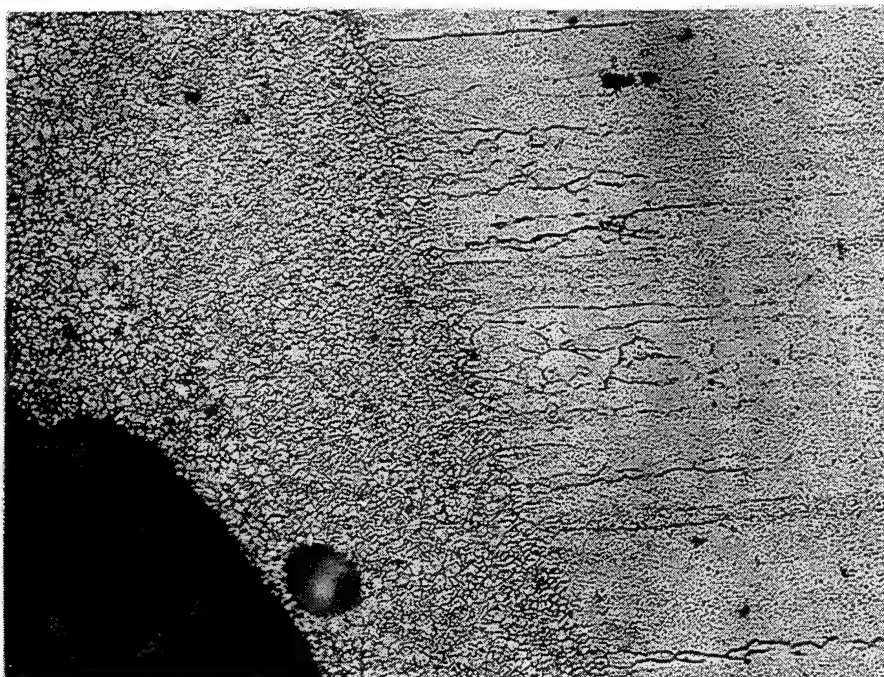
where the cracks are located, is an area of over-aged aluminum. In this region, the heat was just enough to cause the magnesium and silicon in Al-7475 to diffuse out to the grain boundaries of the aluminum, substantially weakening the aluminum causing it to crack. These cracks were not formed from mechanical stress--they were formed from material changes brought on by the heat.

Figure 8
Microstructure of root (500X)

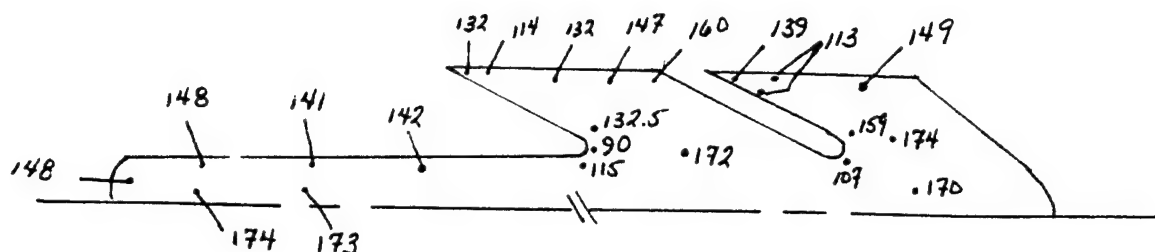
The hardness of Al-7475 is supposed to be 170-175 DPH. The hardness of the aluminum sabot is lower than this because of exposure to intense heat in the launcher. Figure 9 shows the hardness values from selected regions of the sabot. Only the central body of the armature did not experience hardness degradation. Softening occurred along the contact surfaces, at the roots of the contact surfaces, and along the tail or penetrator stabilizer area. The lowest hardnesses were seen at the tips of the contact surfaces and at the roots.

Figure 9
Hardness profile of sabot

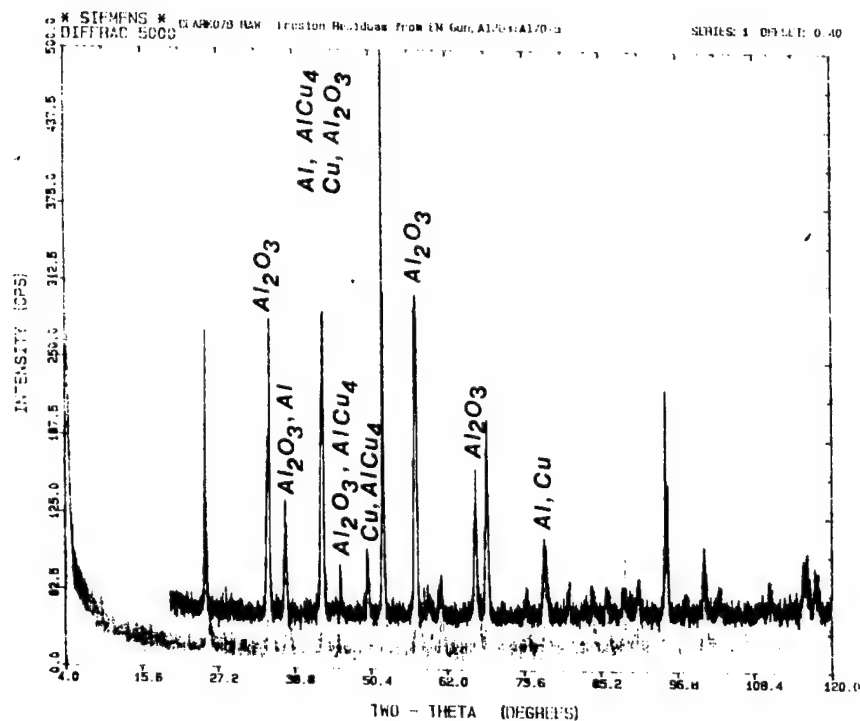
An x-ray diffraction spectrum was obtained from the debris (fig. 10). Some of the peaks were identified as aluminum, aluminum oxide (from the insulating sidewalls in the launcher), and copper; however, many of the peaks could not be identified. This points to non-stoichiometric alloying of these elements which is caused by incomplete melting and mixing.

Figure 10
X-ray diffraction pattern of black residue

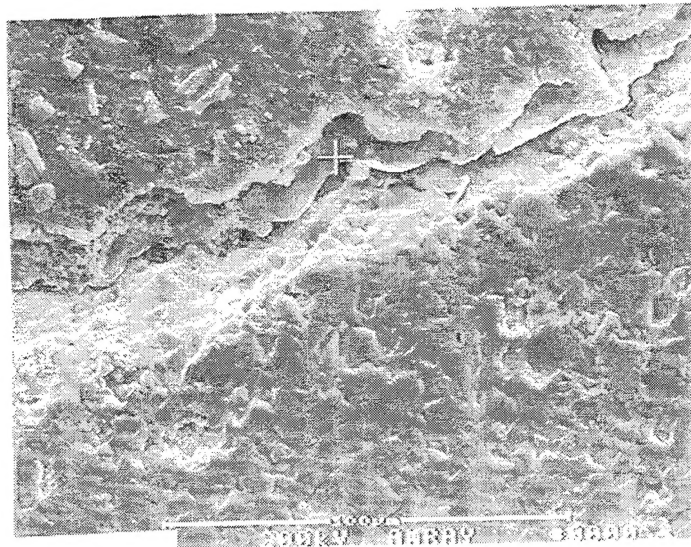
The microstructures of the larger chunks of debris from commissioning shots were analyzed. Figure 11 shows a 5 μ layer of black residue on a piece of the aluminum oxide insulating wall. Most of this black residue deposited on a piece of the aluminum oxide insulating wall in the form of submicron particles (fig. 12). However, there are also deposits of chromium-copper 30 μ wide that have landed on the wall in a molten

Figure 11
Layer of black residue on sidewalls (540X)

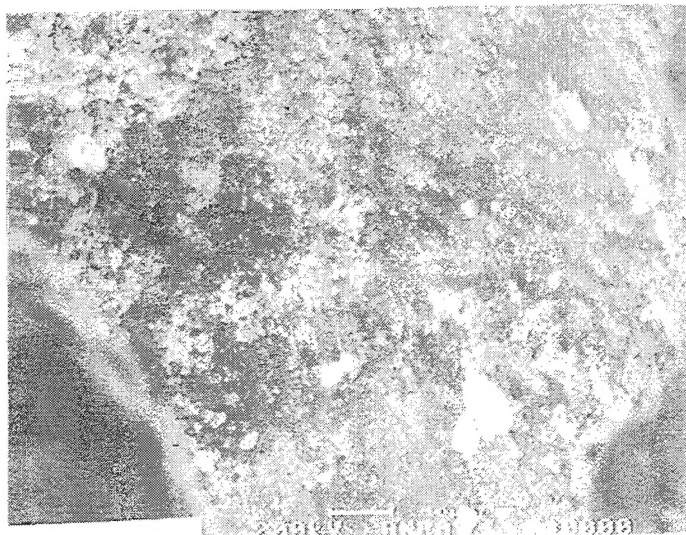
Figure 12
Black residue composed of submicron particles (825X)

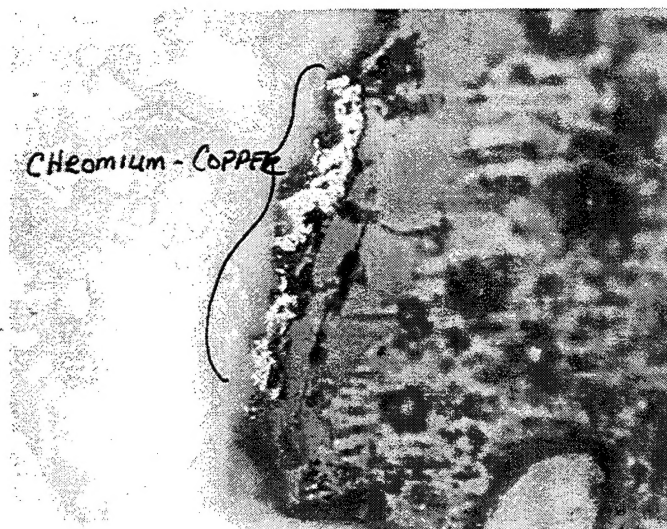
Figure 13
Chromium-copper deposit on sidewalls (300X)

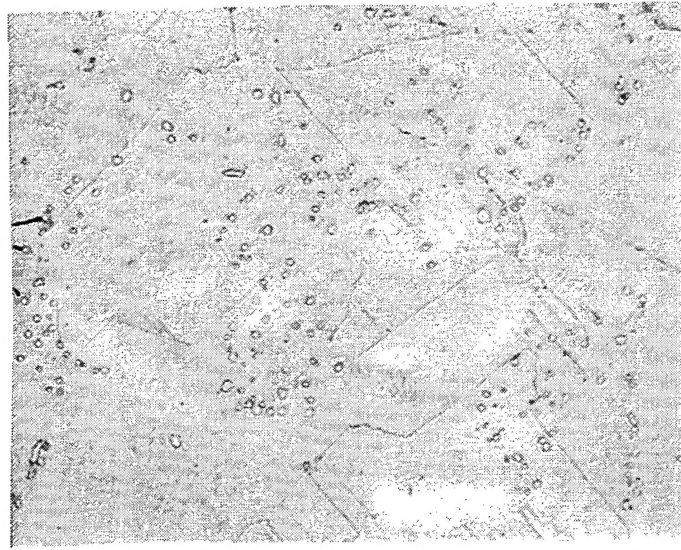
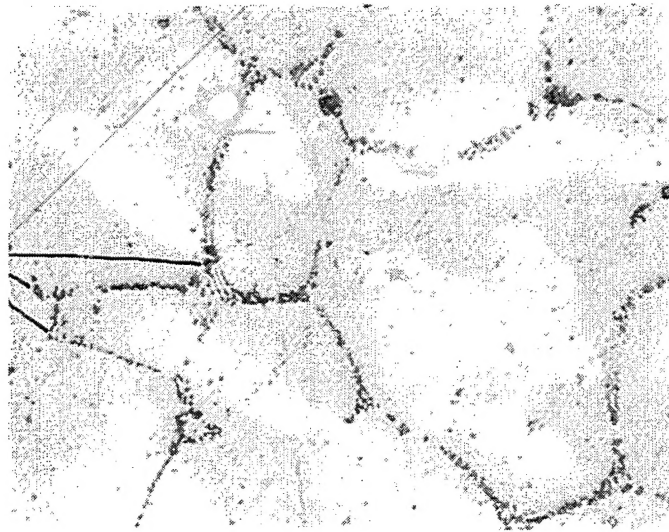
Figure 14
Microstructure of chromium-copper and chromium-copper deposit

globular state (fig. 13). Due to melting and resolidification, the microstructure of this rail material has changed. Compare the original microstructure of the chromium-copper rails (fig. 14a) to the microstructure of the glob formed during commissioning (fig. 14b). In figure 14b, the chromium has come out of solution and migrated to the grain boundaries of the copper. It is unknown how hot the chromium-copper got or how fast it cooled in order to produce this microstructure. This change in the microstructure also points to changes in the physical properties of the chromium-copper such as hardness and conductivity. The original average hardness was 128 DPH, but the molten material has an average hardness of 70 DPH, which is very low. Since the conductivity of a material is usually inversely proportional to its hardness, it is likely that the conductivity has increased. No actual conductivity measurements could be made on the material since there was not enough to test.

(a) Original microstructure of the chromium-cooper rails (750X)

(b) Microstructure of the chromium-copper deposit (750X)
